Failure of Bridge Structures in Extreme Floods

CASE STUDY OF CHADOORA BRIDGE

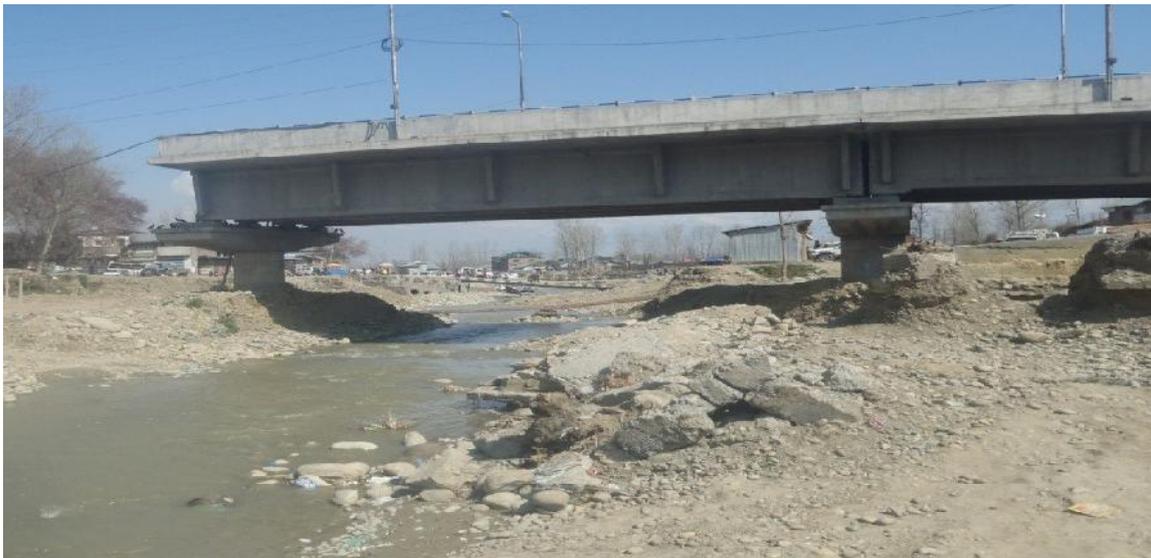
Figure 1 Chadoora Bridge

The Chadoora Bridge as so called is located at tehsil chadoora in district budgam, Kashmir, India. This bridge connects the two important tehsils .The trade, communication and public transport wholly depend on this bridge .Originally constructed by R and B division Kashmir in 2001 – 2002 year, the bridge is a balanced cantilever bridge with 108.3mtr length. This is the image of the Chadoora Bridge taken after floods.

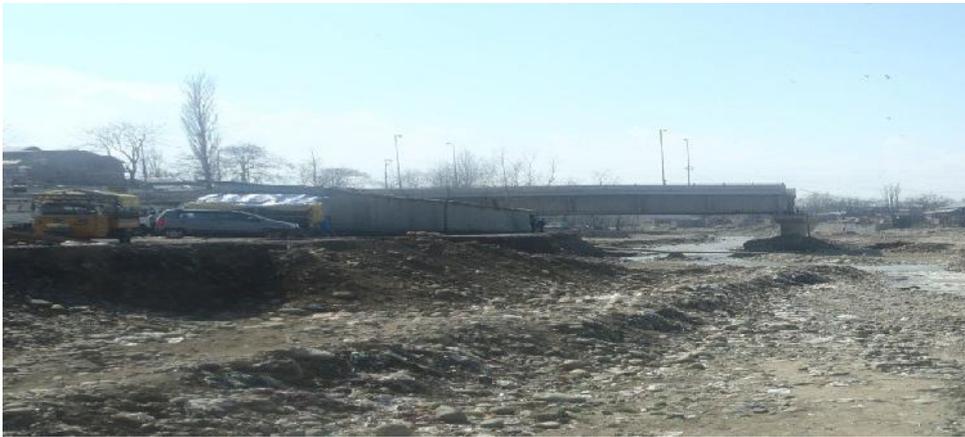
Figure 3 - Failure of the Bridge

1. Back in 1973, the discharge recorded at doodganga Nallah was 5000 cusecs. On September 2014 the discharge was 9504 cusecs. But this high discharge is hardly a criterion for the failure of the Chadoora Bridge. The length of the bridge is 108.3mtrs, but during floods the linear waterway was recorded only 36.6mtrs which is negligible for such a major bridge.

This is the picture of Chadoora Bridge again and shows the doodganga Nallah on which it is constructed. As we can clearly see the how waterway is reduced. We can see is that there are no river training works on this particular bridge which also play its part in failure of the bridge.

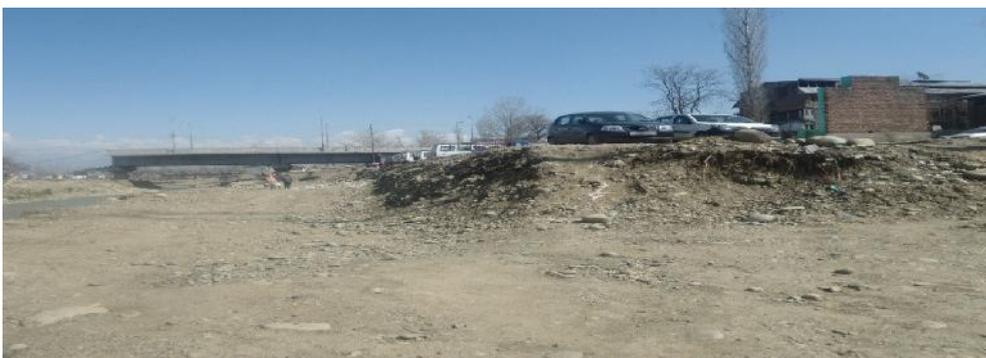
Figure 4 Bridge after the Floods

3. The scouring of the bridge has also taken place due to massive slides on river side of left abutment. The obvious cause of the scouring has been encroachment of almost 75% of total waterway, both on upstream and downstream side by the way of the creation of the eidgah and sumo stand respectively. This cause the scour of the pier. The pictures below will tell us the condition of the bridge and will indicate how waterway was reduced. The pictures were taken after the floods on the site.

The above figure clearly shows how the construction of the shed, taxi stand etc. reduced the waterway of the bridge and thereby not giving free and full passage of the flood to pass which lead to scour failure of the bridge.

4. The discharge of 9504 cusecs which should be pass through at least 91.5mtr width, only passed through 36.6m, thereby causing the scour failure of the bridge.
