Slope Stability Analysis of Nung Dolan Landslide, NH-37 Manipur, NE-India: Geotechnical approach

Kh Mohon Singh

Department of Geology, Imphal College, Imphal, Manipur

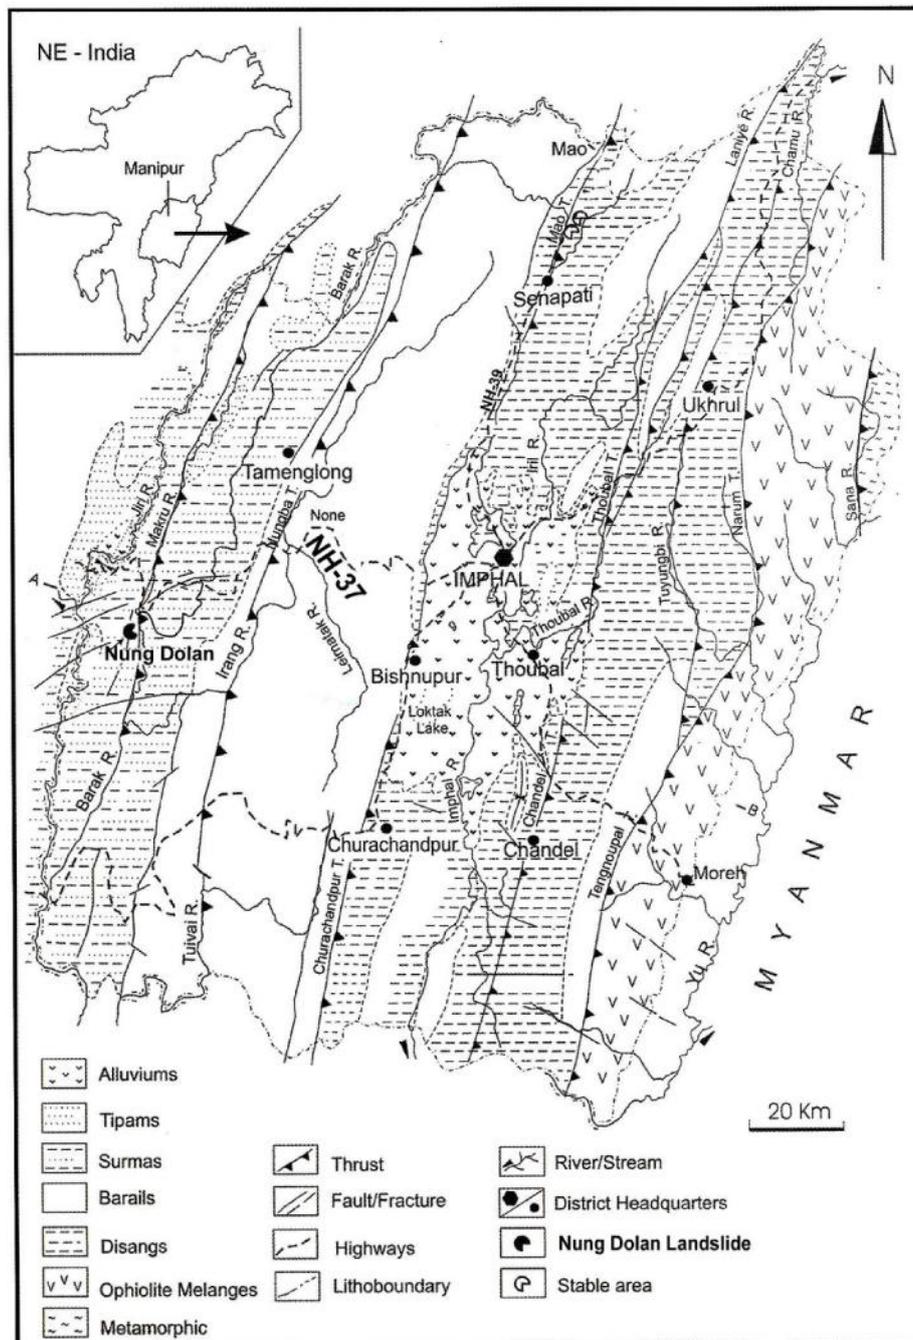
Figure 1: Geological map of Manipur (modified after Soibam, 1998) showing Nung Dolan Landslide (Source: Earth Sciences Deptt., Manipur University).

Any constraint in these two highways affects the people of the state in many ways and dimensions. One of the main factors contributing to frequent landslides in Manipur is the fragile nature of the litho units, resulted from the rock types and structures characterizing these rocks. However, certain places are found to be covered with thick columns of soil rendering instability conditions. Engineering properties of rocks as well as soils and variation in moisture contents play major role in initializing slides on these slopes. So, in this paper we try to analyze the geotechnical properties of the rocks as well as the soils on the slope at Nung Dolan situated along the National Highway-NH-37 with a view to work out the instability conditions of the slope masses. The present investigation area falls under Survey of India (SoI) toposheet No. 83 H/5 at 24°46 8.2'N & 93°18 1.3'E. Geological formations exposed in the study area are highly fragile, jointed and structurally complex, belonging to the Surma group which is mainly made up of sandstone and shale with minor conglomerate at places.

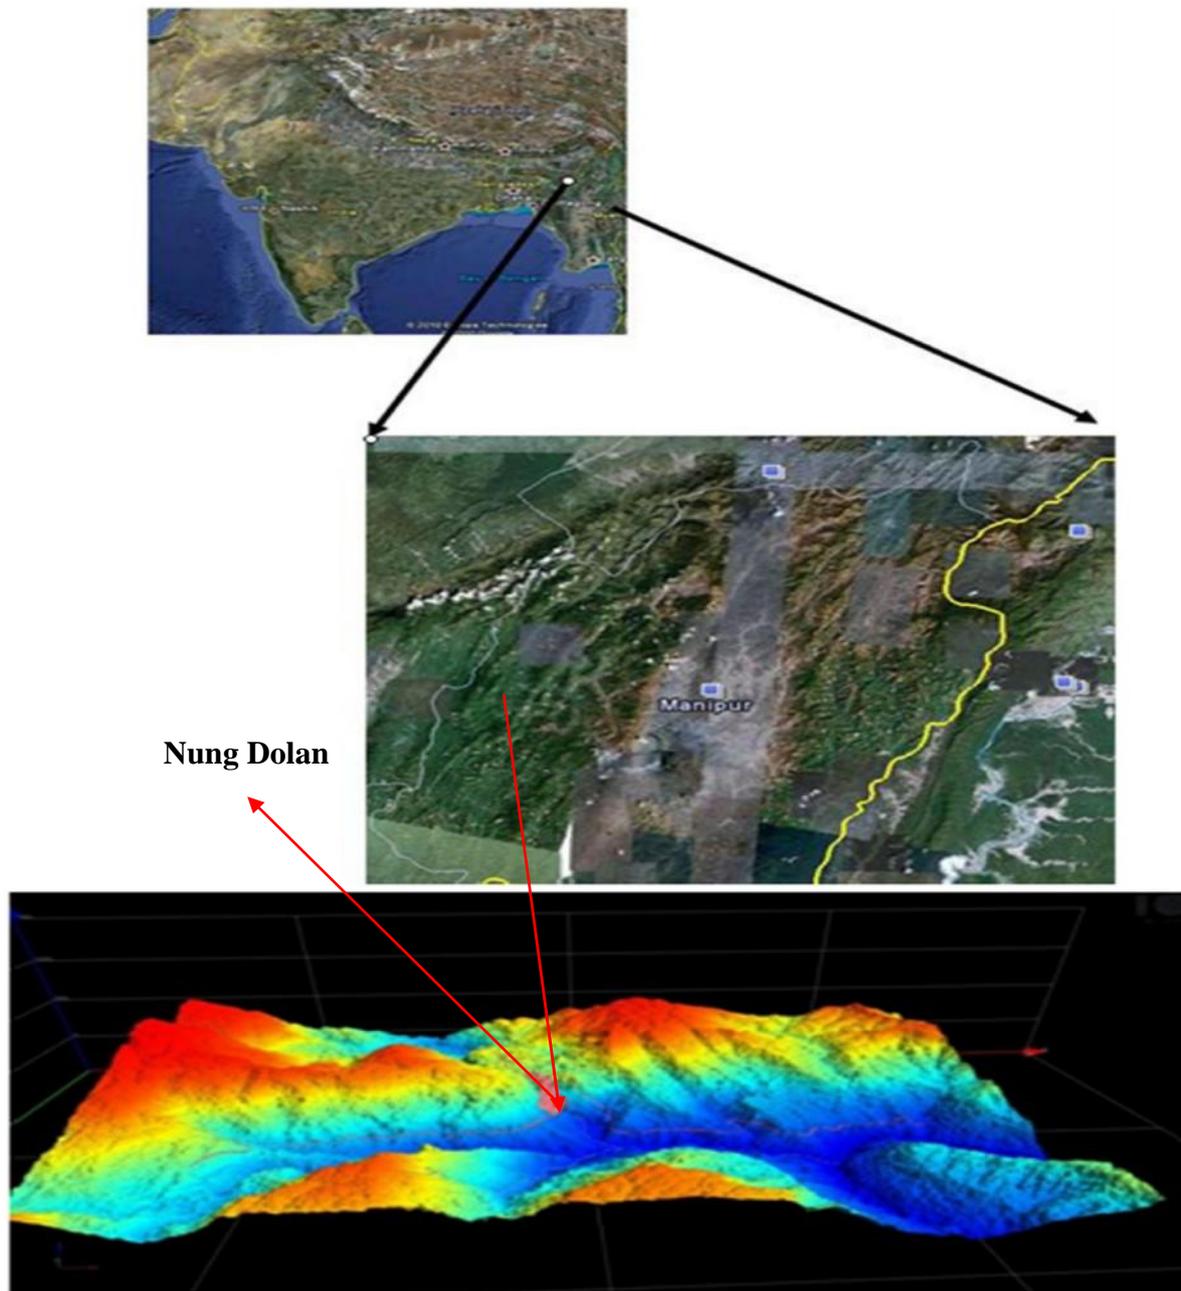
Figure 2: Location showing Nung Dolan Landslide & DME of Nung Dolan Landslide

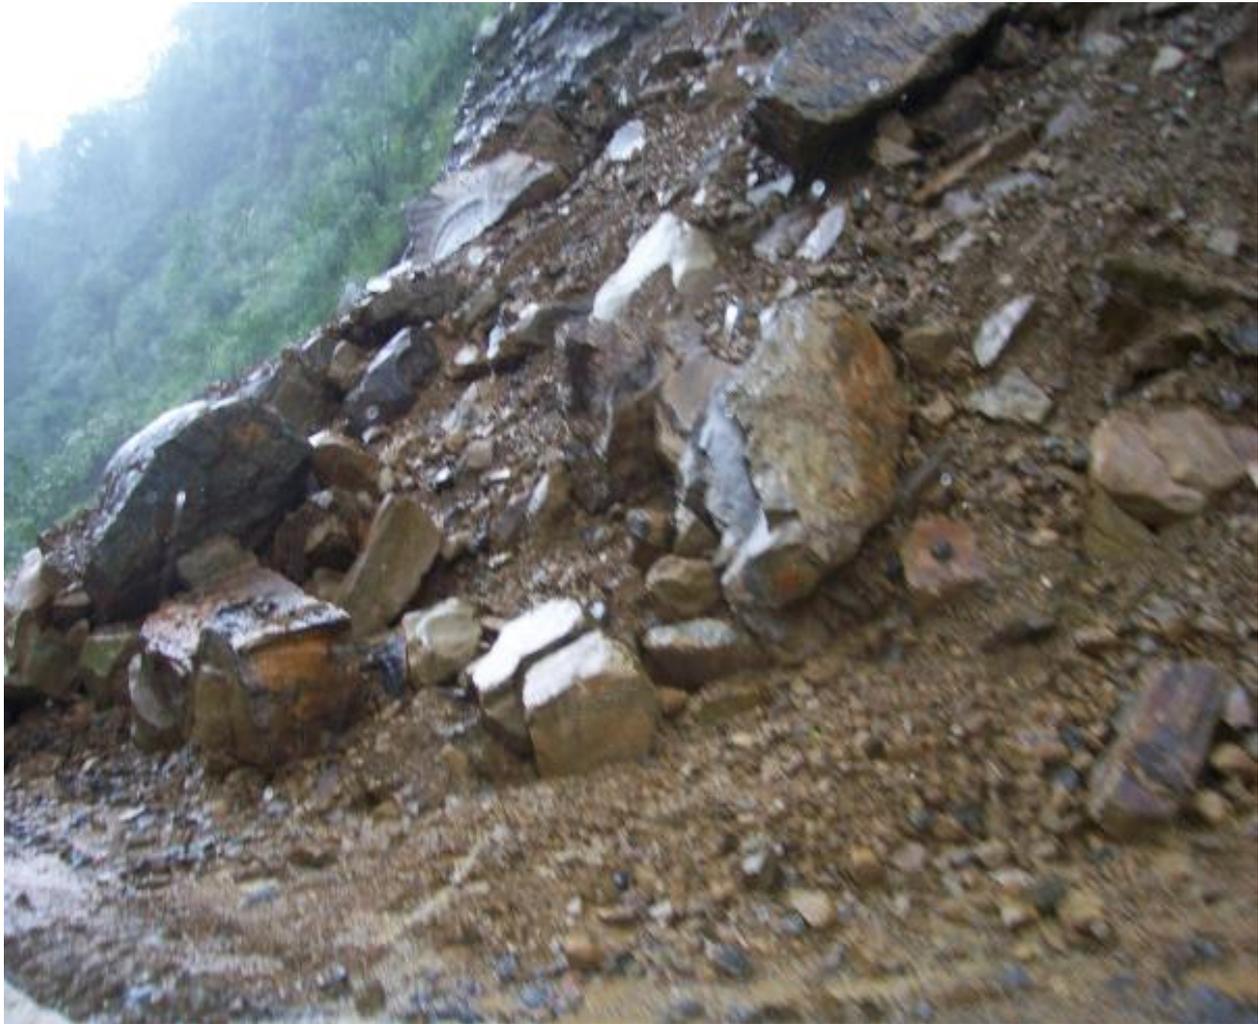
Figure 3: The sliding area is not a small portion but larger areas are affected.

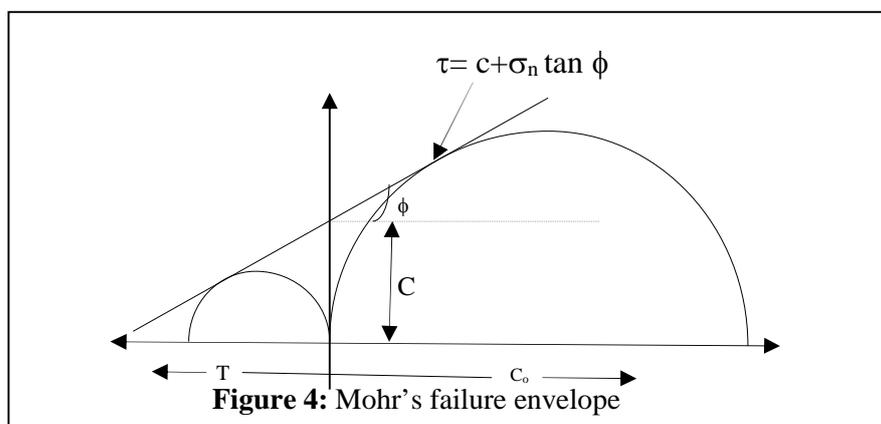
The results obtained from these tests can be plotted using Mohr's stress circle in which the value of compressive strength are laid out to the right of zero on the horizontal axis while that of the tensile strength on the left of zero. In this method, the values of these strength parameters i.e. of the uniaxial compressive and tensile strengths are taken as diameters for their respective circles. A common tangent to both the circles is drawn as shown in the Fig.3. The point of intersection of this line with the Y-axis or τ -axis (Shear Stress) gives the value of cohesion, C and its slope represents the internal friction angle, ϕ . The point in which this tangent touches the right circle gives the value of normal stress, σ_n (along x-axis). By knowing these values, one can calculate the failure envelope, adopting the formula, $\tau = C + \sigma_n \tan \phi$.

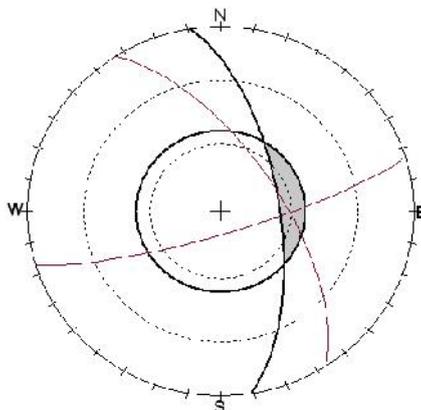
Figure 5: Stereo plot showing probable mode of failure.

It has been inferred that wedge failure is the probable mode of failure of the landslide where the intersection of joints (J1 & J3) lies in the shadow area by using Rockpack III, the plunge of the intersection lines of discontinuity is $60^\circ/092^\circ$. Wedge failure is the mode of failure when the plunge of intersection lines of discontinuity is less than the dip angle of the slope face (Markland test).

Discontinuities data collected from the field are systematically processed and tabulated so that it can be effectively used to analyse stereographically using Rockpack III software, to determine the probable mode of slope failures (Figure 5).

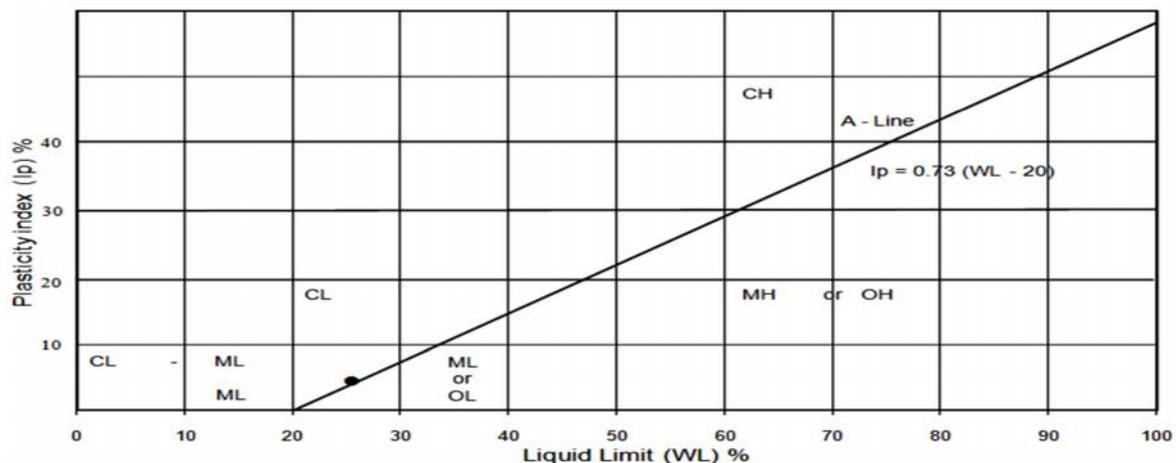
Figure 6: Plasticity chart of Soils

In the present study of soil properties of the slide, soil has less moisture content and from the plasticity index charts the soil samples come under CL group suggesting slightly plastic soil of inorganic nature. Hence we can conclude that the (-ve) value of **(-1.18)** liquidity index and the (+ve) value of **(3.03)** consistency index, indicates that the slope forming materials remains in solid state or semi solid state.
