## Study Of Submersible Hydraulic Structures, A Critical Review

**ABSTRACT** *Submersible hydraulic structures such as Fords and Raptas are preferred mainly in mountainous regions where hilly roads cross many torrential rivers enroot to save the cost of the highway projects. The proper design and location of these structures are an important issue as these structures have to serve two main purposes i.e. passing of river water and also to cater the traffic demand simultaneously. In this paper a critical review of few important causeways are carried out. An attempt has been made to critically examine the nature of scour and deposition around them in various flow conditions and changing geometry of the natural streams. It is found that generally there are two types of causeways, one in the form of plane concrete slab without any vent over which water and traffic both move while in another type there are vent for passing water from u/s side to d/s and traffic move over the causeways. In both types there is scour and deposition which depends upon many factors such as type of causeways, intensity of discharge, sediment size and curvature of natural stream. Suitable precautionary measure

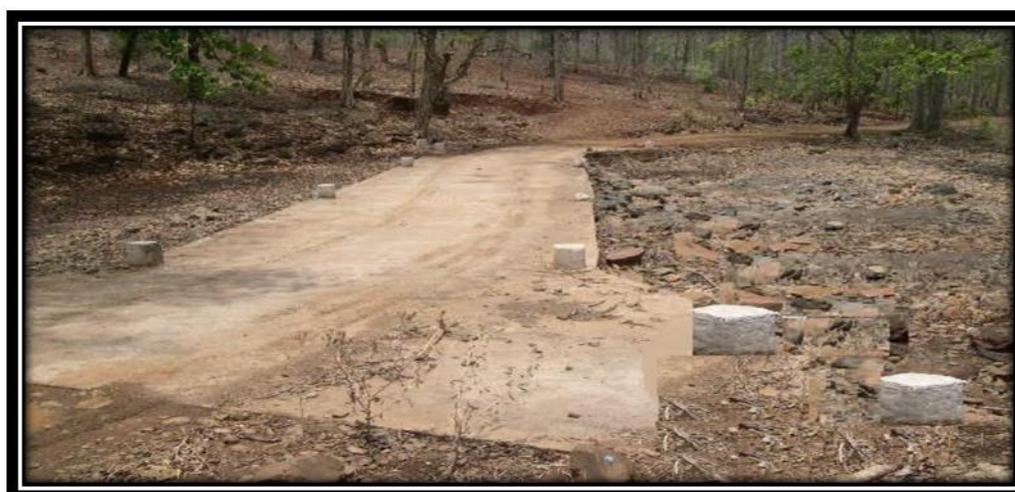
**Fig1.Garouti -Tindwari Causeway, Dist. Banda, U.P ( Flush Causeway)**

In this type of causeway which is also called paved dip or road dam, the top level of road is kept same as that of bed level of the channel (Fig. 6). It is suitable where the crossing remains dry for most of part of year i.e. the stream is not perennial. Flush causeways are not suitable for crossing the streams with steep bed slopes causing high velocity even in low floods. The causeway covers the full width of the channel.

Few local causeways of district.Banda.in state of U.P. have also been cited in this thesis. Amongst these are Tigoria Nala causeway having length 25 m, width 7.5 m and depth as 2 feet. ( 0.60 m), Papreksha Pailani causeway also called Girganhnari rapta with length 25 m, width 7.5 m and overall depth as 2.5 feet and Garoati Nala. Tigoria rapta was constructed in 2005 and repaired in 2009. Similarly Ppreksha rapta was constructed in 1978 and repaired in 2009. Also Garouti rapta was constructed in 2006 and get repaired in 2009. About 40 lacs rupees was invested in these separate works.

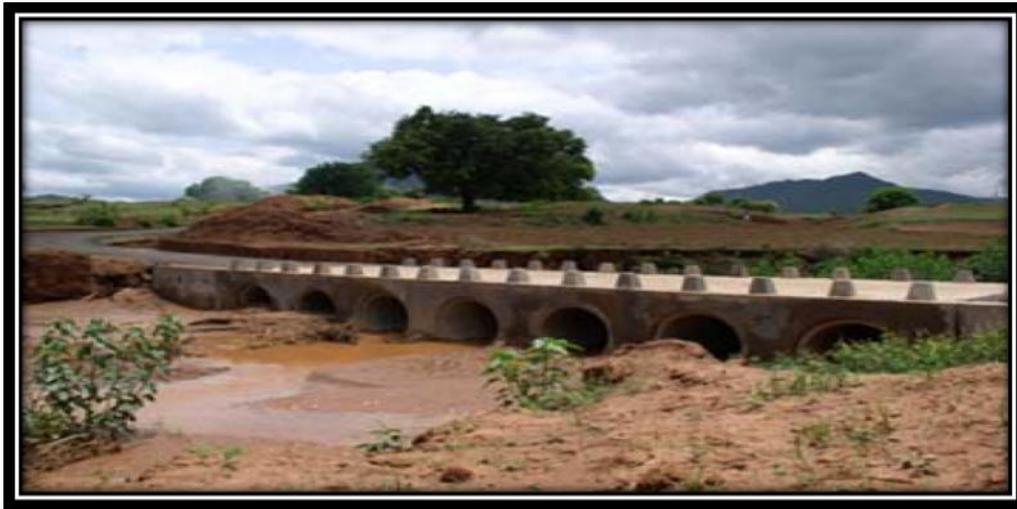
**Fig. 2 Low Vented causeway over PitesuNallah (Orissa)**

Low vented causeways (Fig.7) are provided to cross quasi-perennial streams having sandy beds in areas with annual rainfall less than 1 m and where the carriageway of a flush causeway would be liable to get slushy due to post monsoon flow in the stream.

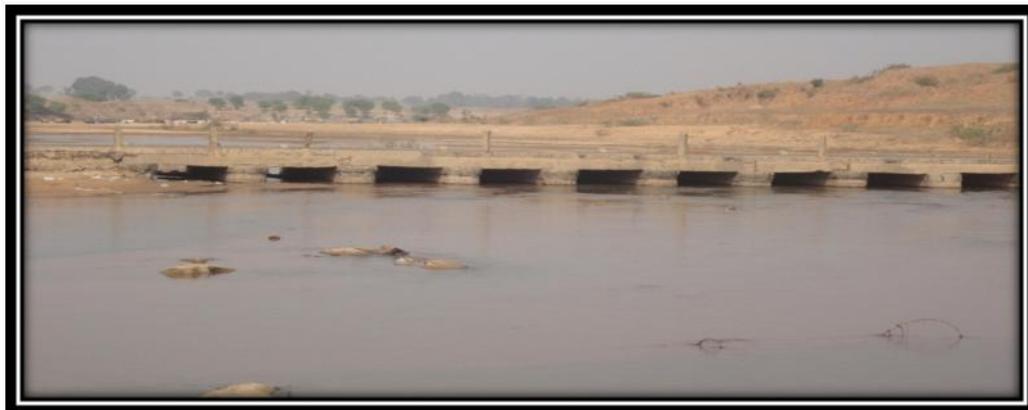
**Fig.3 High vented Causeway on Kewai River ( M.P.)**

High vented causeway (Fig. 8) is provided when a road crosses a stream having one or more of the following characteristics:

The height of the causeway above the bed is generally kept between 1.5m to 3.0m and larger size of vents comprising of Hume pipes or simply supported/continuous R.C.C. slab superstructure over a series of short masonry piers or series of arches or boxes with individual spans less than 3m are provided.

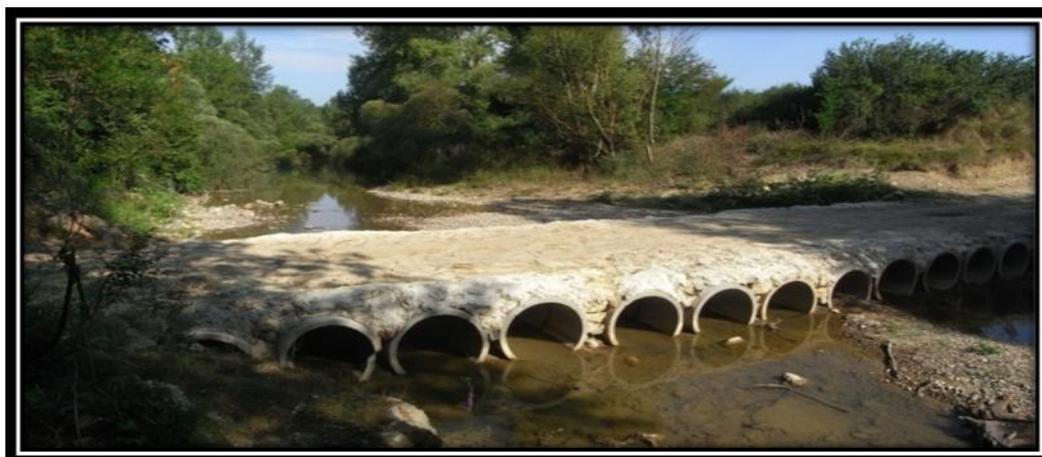
**Fig.4 Causeway on (Feccia River Italy)**
